**DEPARTMENT OF DEFENCE**  
**DEFENCE SCIENCE AND TECHNOLOGY ORGANISATION**  
**AERONAUTICAL RESEARCH LABORATORY**  
**MELBOURNE, VICTORIA**

Research Report 12

**DAMAGE STATES AROUND FASTENER HOLES IN THICK  
GRAPHITE/EPOXY COMPOSITE LAMINATES**

**S.C. GALEA  
G.K. DEIRMENDJIAN  
D.S. SAUNDERS**

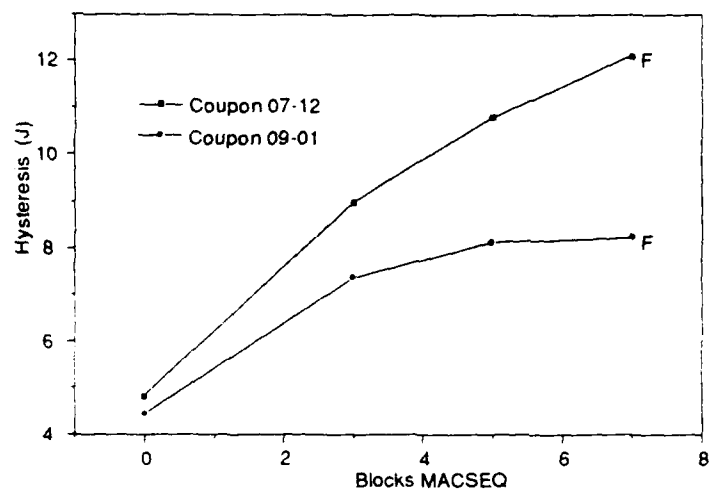
The hysteresis behaviour of specimens fatigued under MACSEQ with a peak load of 36 kN showed similar initial trends but a full stabilisation of hysteresis was not realised because of fastener failures, as seen in Figure 14. Coupon 09-01, from a defective panel, contained a large initial delamination but the coupon displayed less hysteresis change than coupon 07-12 which had no discernible incipient damage. Both coupons had identical initial hole sizes and were tested under identical conditions and so the disparity in hysteresis change remains unexplained. Both coupons lasted 7 full blocks of MACSEQ, and this highlighted the magnitude of scatter in the hysteresis data. These

Figure 14. Variation of area under load/displacement hysteresis curves with increasing number of blocks MACSEQ (36kN) until fastener failure (F).

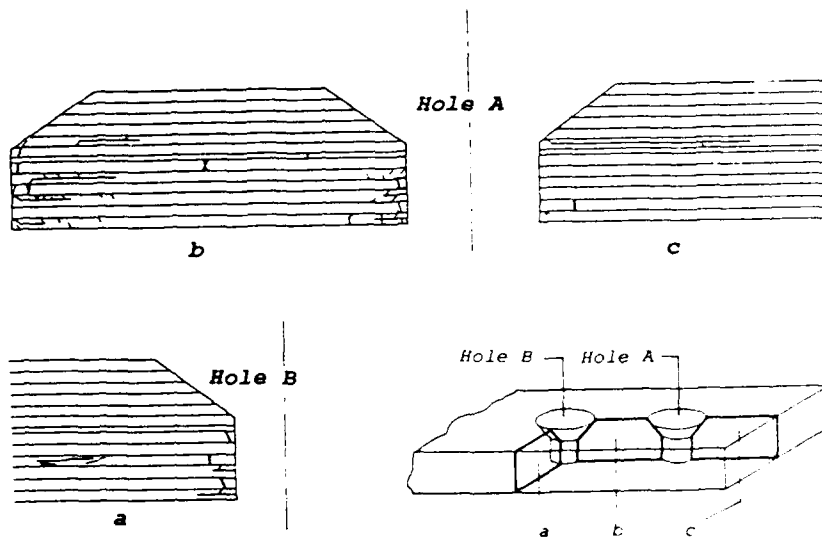
Coupons 04-01, 04-03 and 06-05 were sectioned at the completion of testing. Damage maps of the regions studied were drawn to scale and are presented in Figures 23 to 25, respectively, where individual section maps are also provided. These coupons were tested under the lower MACSEQ spectrum loads and results of the scanning electron and optical microscopy were reported in [9]. The damage conditions of the hole surfaces developed under fatigue loading are reproduced from reference [9] in Appendix 1. Here Figures A.1 to A.4 show the fastener hole surfaces and profiles for coupons 04-02, 04-01, 04-03 and 06-05 at loading blocks 5, 15, 45 and 90 respectively.

Figure 23. Damage maps from coupon 06-05, fatigued to 90 blocks MACSEQ (30 kN peak load).

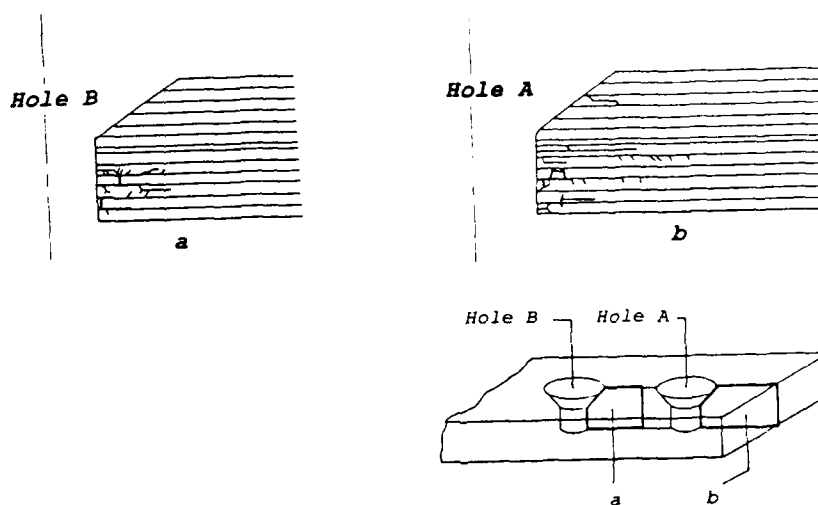
Figure 24. Damage maps from coupon 04-03, fatigued to 45 blocks MACSEQ (30 kN peak load).

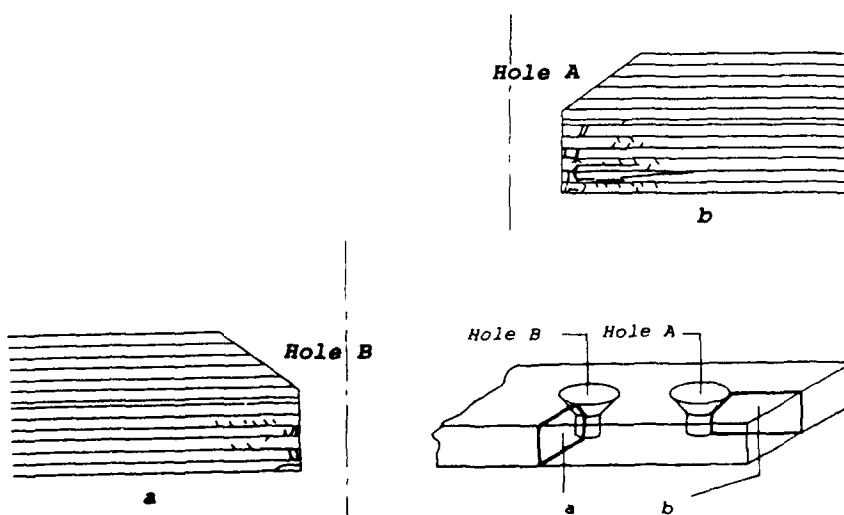
Figure 25. Damage maps from coupon 04-01, fatigued to 15 blocks MACSEQ (30 kN peak load).
